# **2015 Summary Report**

# Burrard Inlet-Indian Arm Eelgrass Mapping

SeaChange Marine Conservation Society and Tsleil-Waututh Nation

Surveyors: Anuradha Rao, Brittany John and Josh George Maps prepared by Sarah Breaks, Tsleil-Waututh Nation Report prepared by Anuradha Rao, MSc, RPBio August 2015

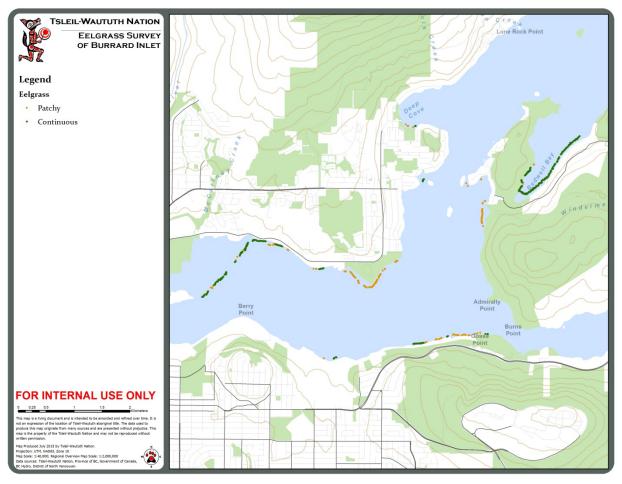
Figure 2. Observed eelgrass locations in Burrard Inlet and Indian Arm

Observed eelgrass locations are presented in Figure 2, with detailed versions of each site presented in Appendix 1. Although the survey extended northward to the Indian River estuary, eelgrass beds were not observed north of Deep Cove.

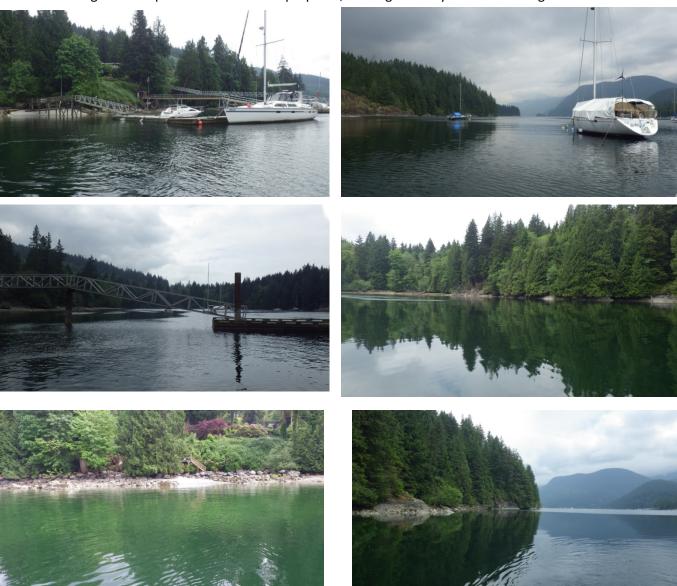
Figure 3. Eelgrass locations in Bedwell Bay

Eelgrass was known to occur intertidally in the head of the bay from traditional knowledge, recent field work by TWN and photographs. During the 2015 survey a continuous eelgrass bed was found subtidally throughout the bay, beginning as fringing beds and developing into a flat towards the head of the bay

(Figure 3). Density was low. At least one boat was anchored in the eelgrass bed, and several moorings were also near the bed. Several adjacent private docks on the east side of the bay extend over the bed, with a gap in the bed beneath at least one dock. Of the various sites mapped in Burrard Inlet and Indian Arm, the eelgrass bed at Bedwell Bay was likely the most extensive and continuous. It is potentially the only location surveyed as part of this study where the bed was extensive enough to be a source location for eelgrass transplants for restoration purposes, although density was still never greater than 25%.
