Saanich Inlet and Peninsula Atlas of Shorelines

**Technical Report
December 2009**

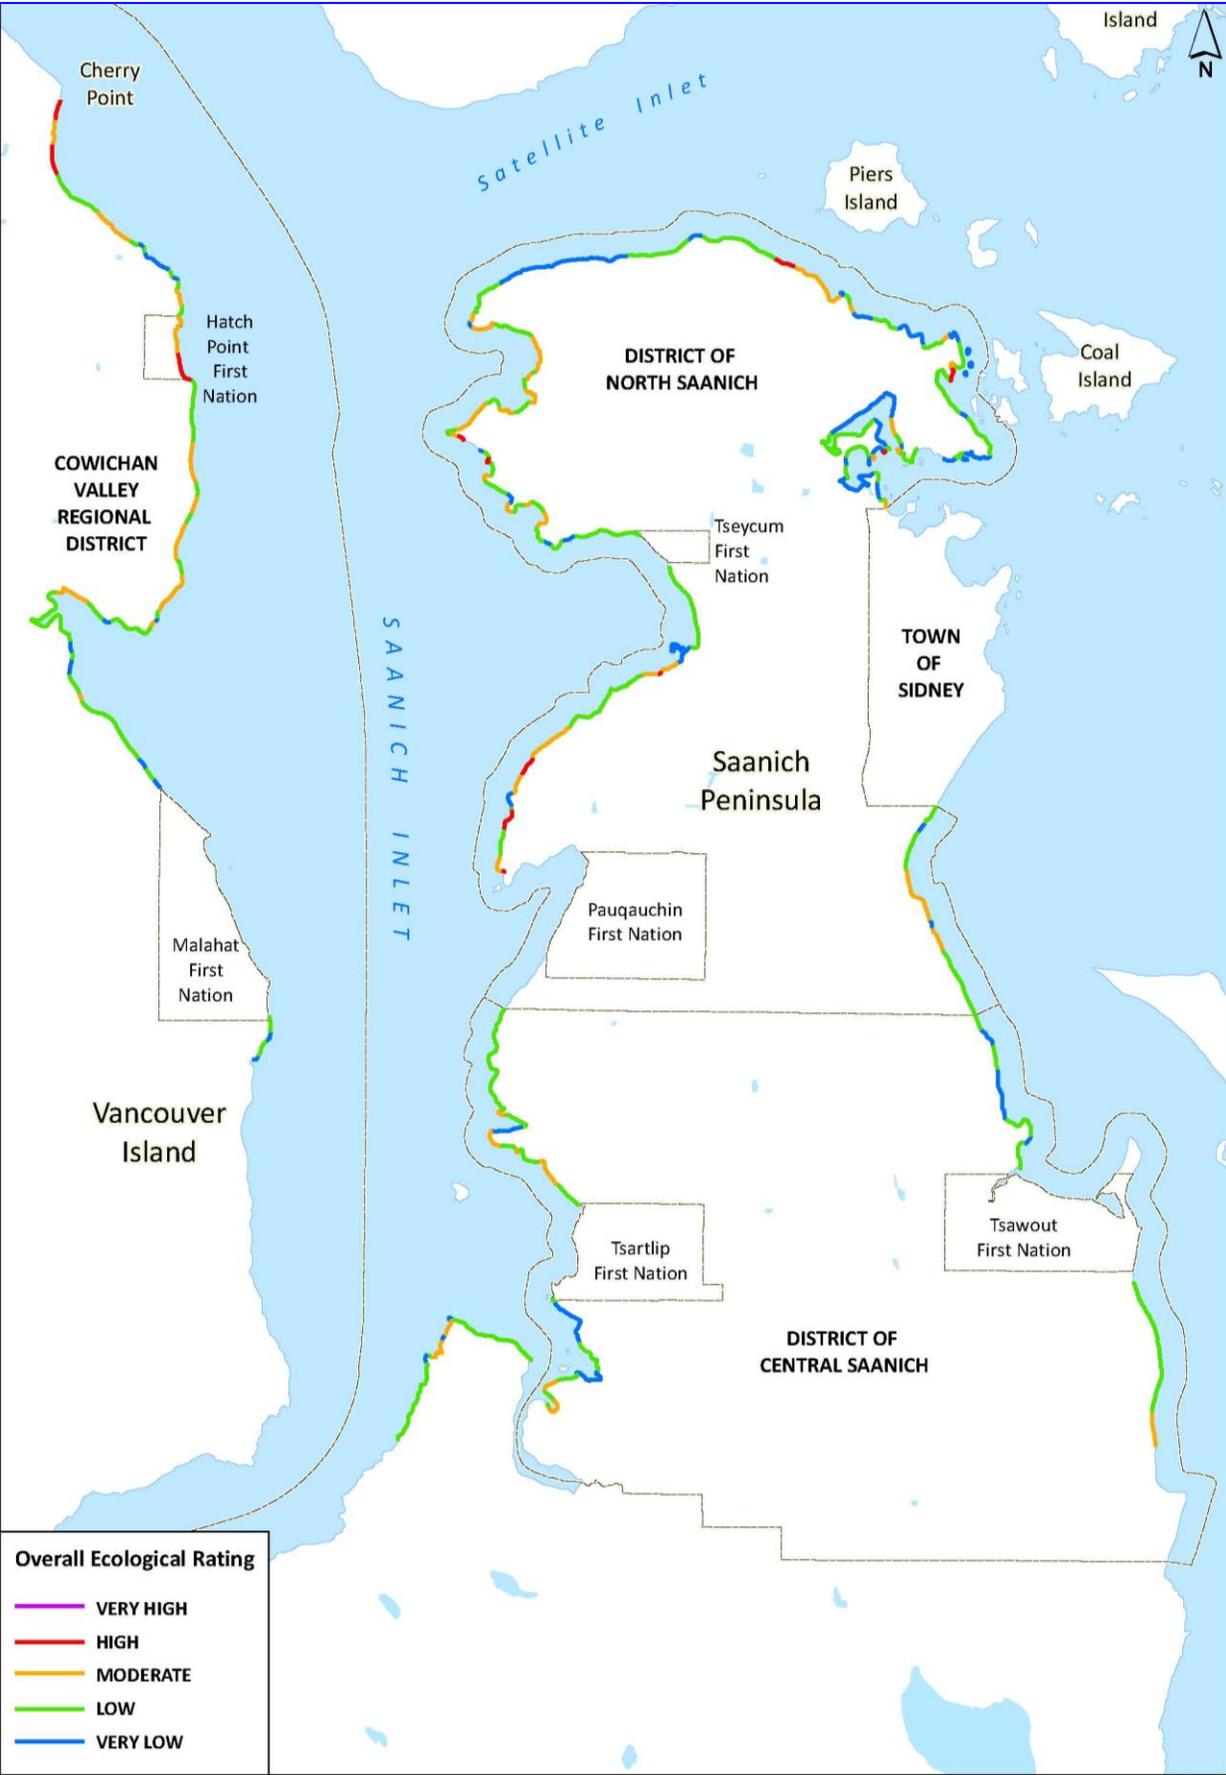
Overall Ecological Rating

- VERY HIGH
- HIGH
- MODERATE
- LOW
- VERY LOW

The shore units in the SIPAS study area have been summarized in Table 5.

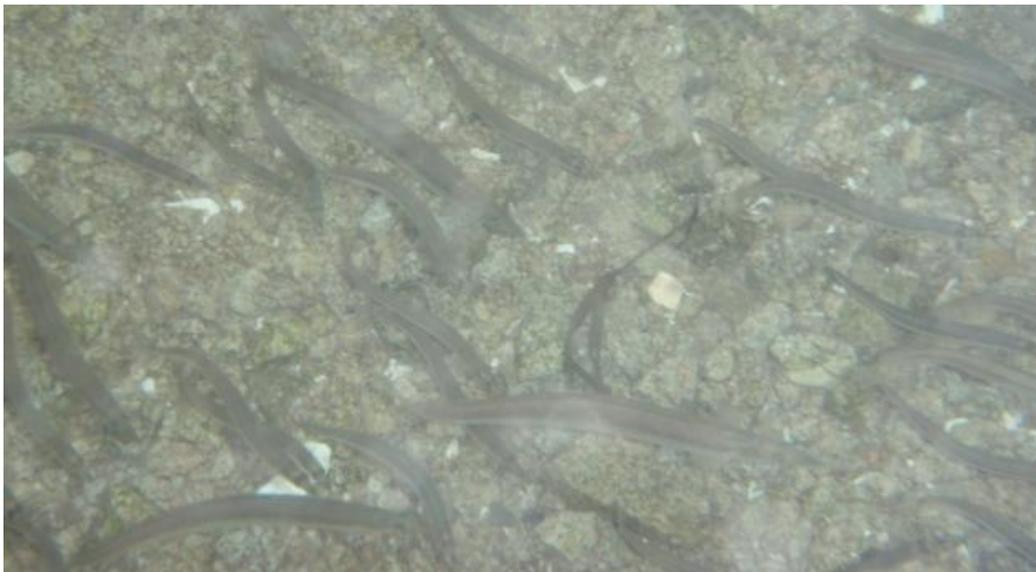
- FIGURE 5: Potential Sand Lance and Surf Smelt Spawning Areas -

Sand lance in Saanich Inlet December 2008

Seven beaches were surveyed over two field seasons for the presence of sand lance eggs from December to January. Presence of eggs was noted in two sites. A survey to visit more of the potential sand lance/ surf smelt spawning sites is underway as of November, 2009. Trained staff with volunteer help collect samples of sand from likely spawning beaches and check for eggs.
