# Squamish Estuary Mapping Summary

Presentation of field work conducted October 5<sup>th</sup> through 7<sup>th</sup>, 2011

Squamish River Watershed Society

SeaChange Marine Conservation Society

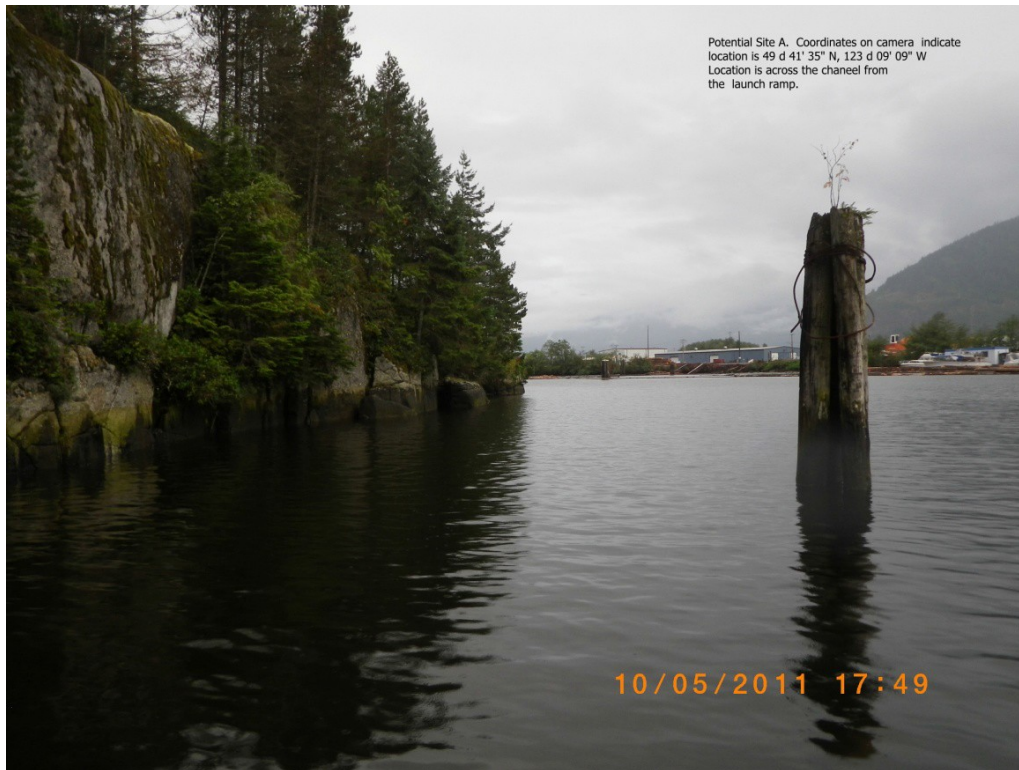
## October 5, 2011, Site A

Notes for the time and photos taken near this time indicate uncorrected depth of -4.6 m. Corrections are -.2 m for transducer location and 3.6 m for tide. The adjusted depth is 1.2 m below chart datum. Crew recalls a sandy location in a fringe along this area of depth. A map of Mamquam Blind Channel is below. There is not a waypoint for Site A, but it lies midway between 30 and 32, across from the launch ramp.

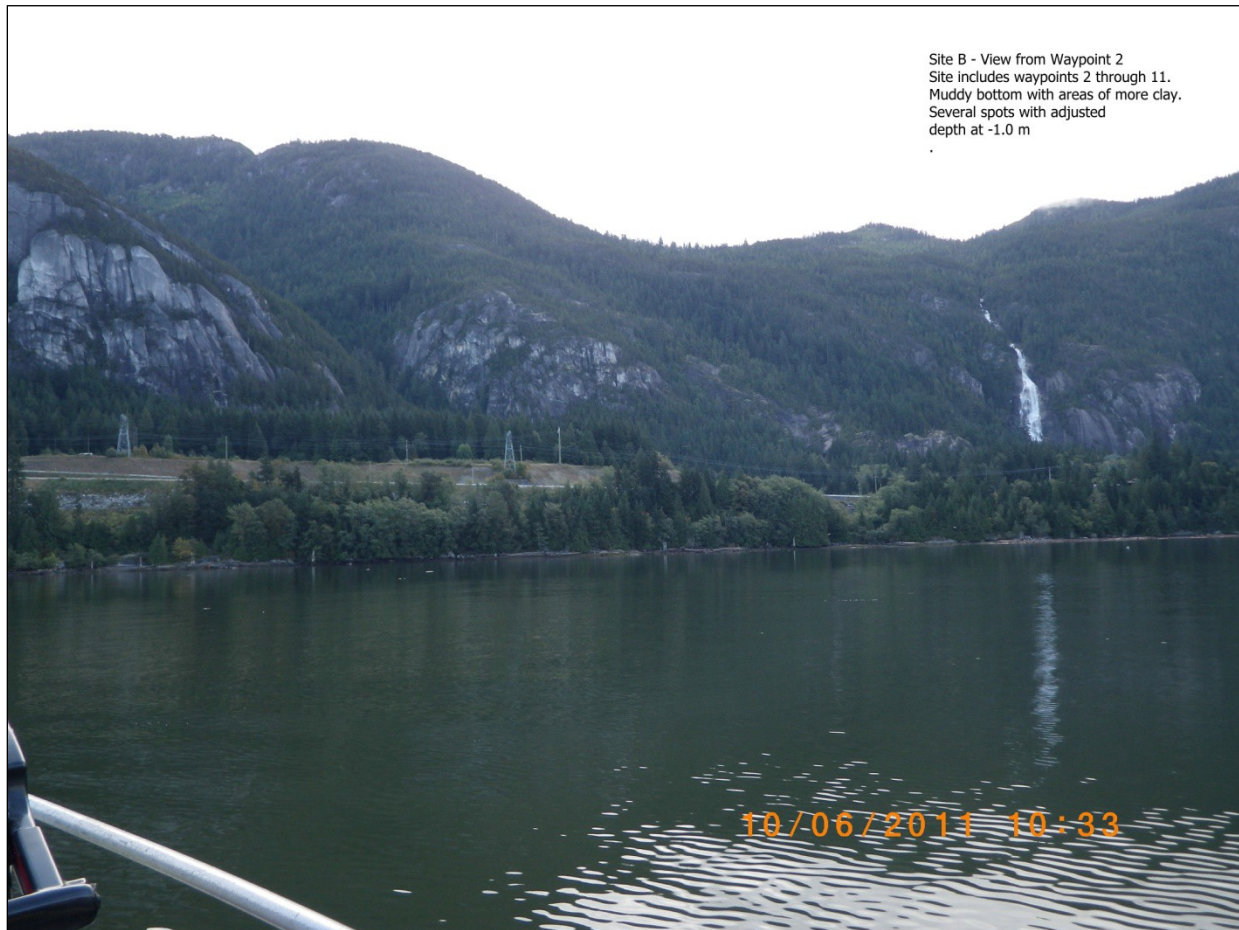
## October 6- Site B

Site B, above, was a large area of muddy bottom with adjusted depths varying near chart datum. The underwater footage shows clams and occasional crab. There were intermittent areas with more clay, but softer mud was predominant. Waypoints 5 and 9 had adjusted depths near -1.0 m. Underwater footage is available to view beginning with waypoint 9. Waypoints 2 thru 11 can be located on Google Earth Map, by following Site C photo.

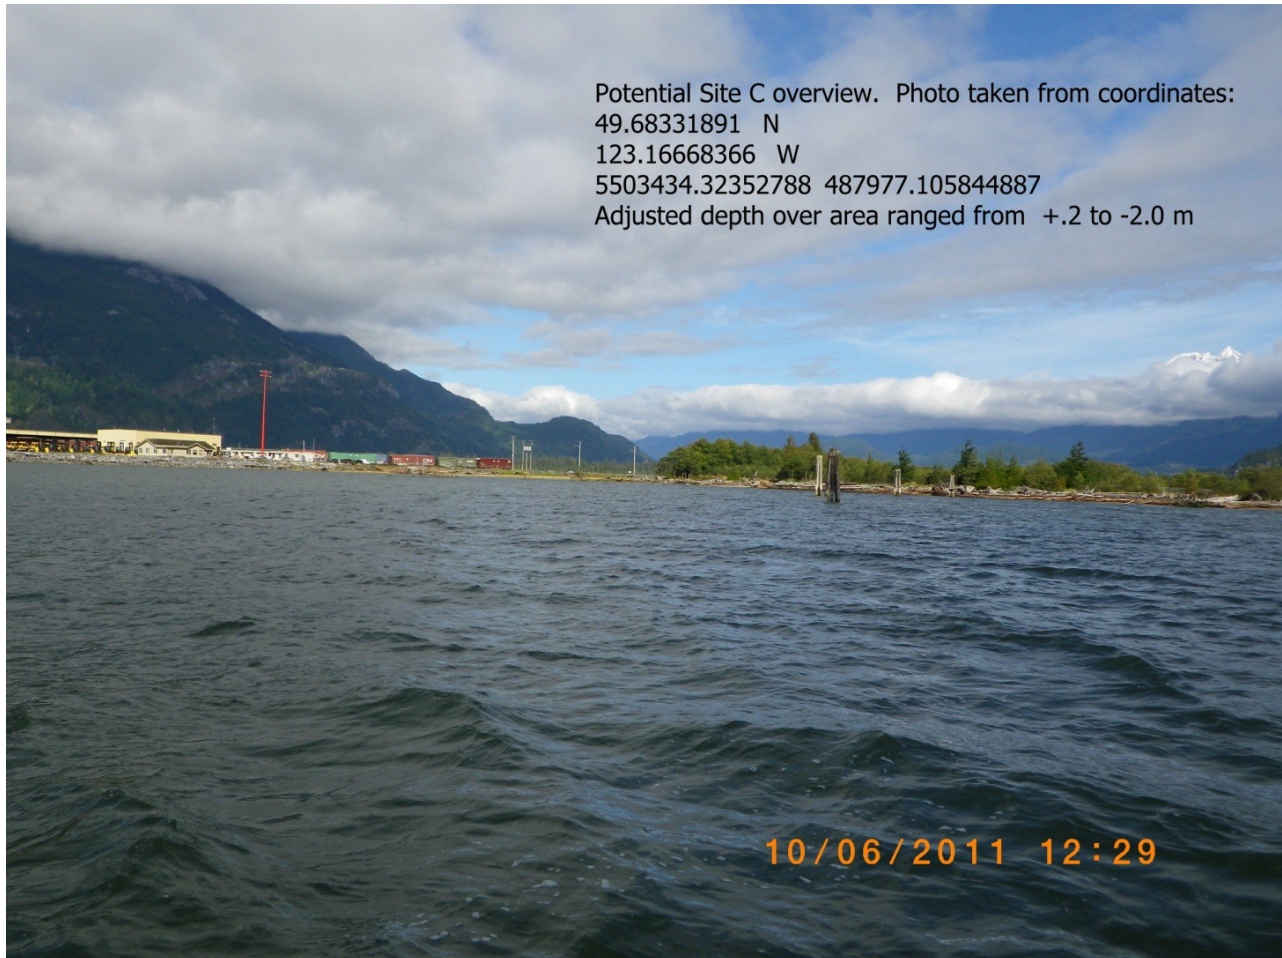
## October 6, Site C

Site C showed promise for a large area with muddy bottom similar to Site B. Concern about benthic mercury from former manufacturing exists. Waypoints 12 through 21 can be located on Google Earth Map b. Waypoints further up Cattermole Slough were generally shallow and can be located on Google Earth Map c.

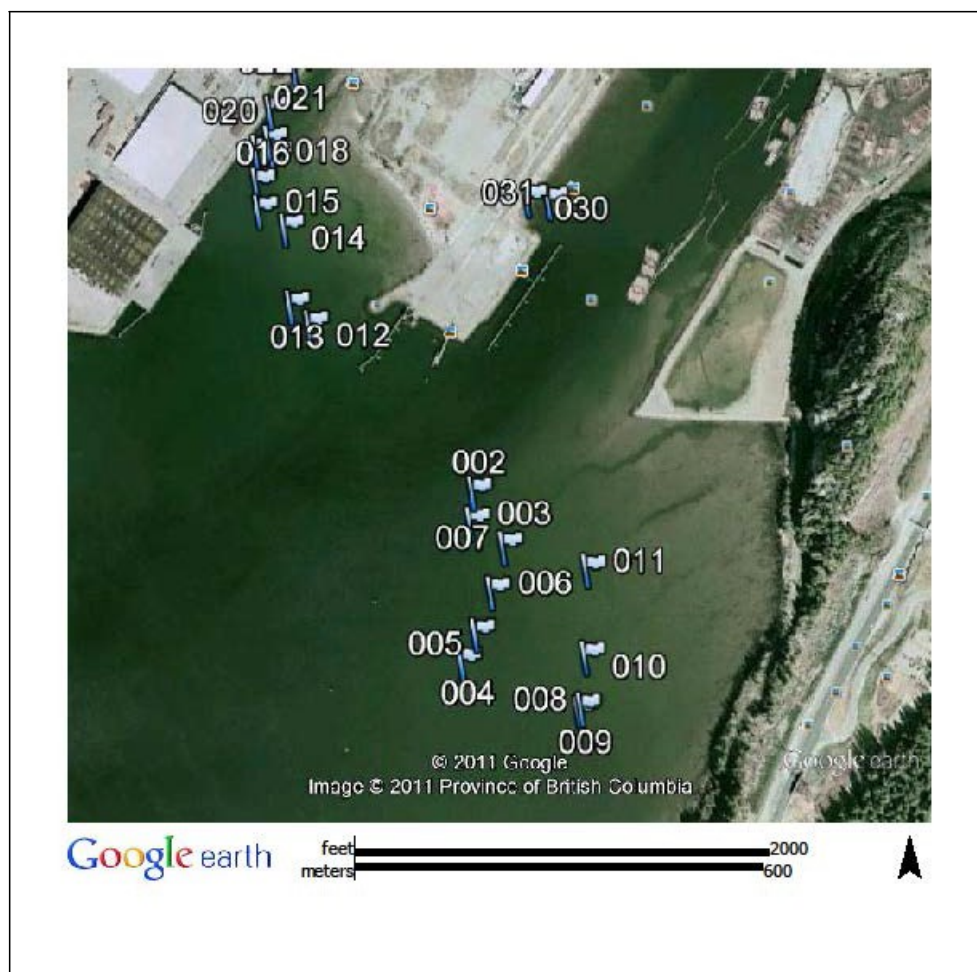
b) Site B waypoints 2 through 11. Site C waypoints are 12 through 21. Transplant around 30 & 31.

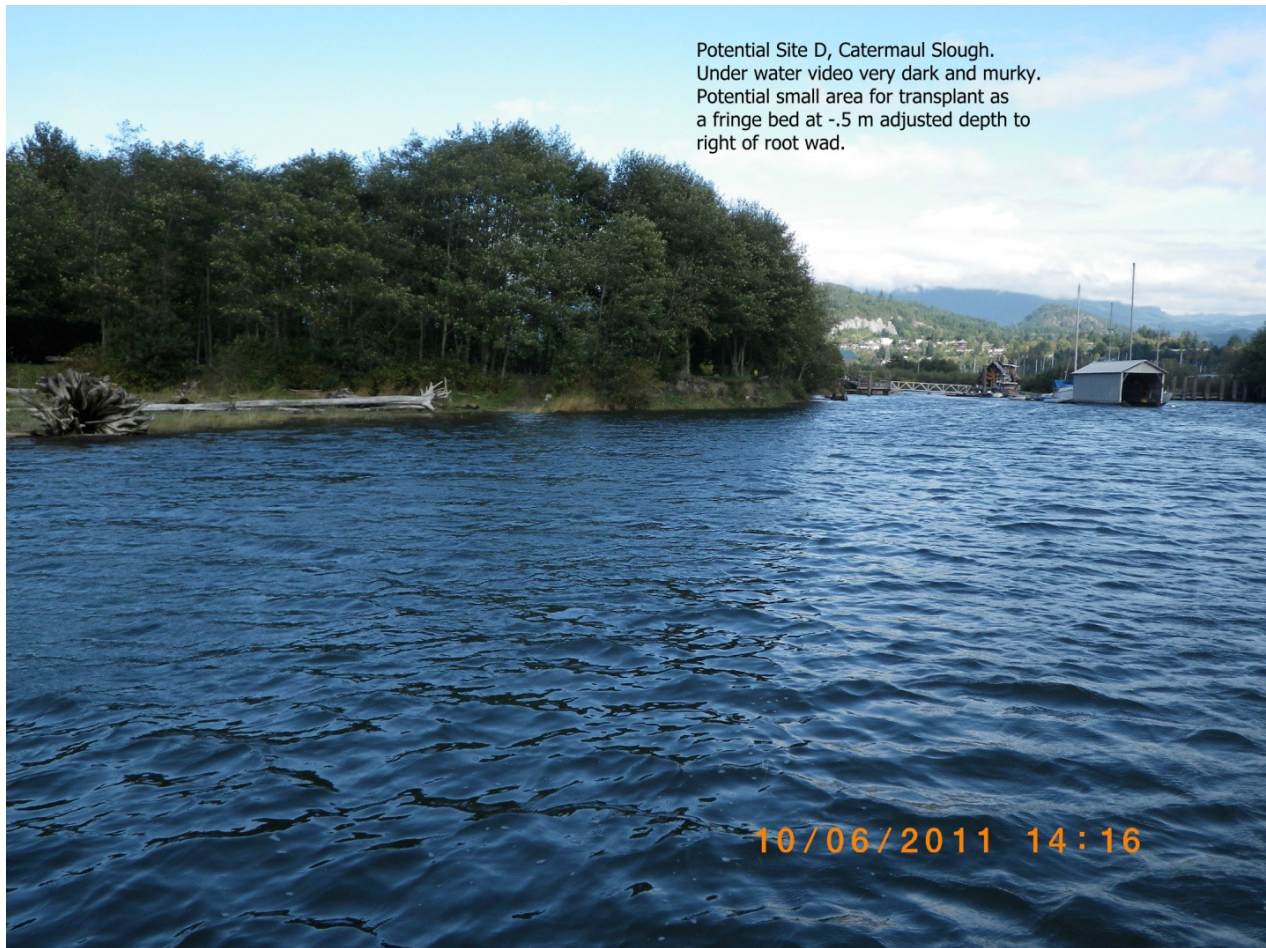
## October 6, Site D

Potential Site D did not reveal much area of the proper depth. Visibility was very murky on Oct 6 in the afternoon with some wind. The protection provided by the upland makes a small transplant at an adjusted contour fringe of -.5 m to -1.0 m tempting once any intended work on the floats is completed.

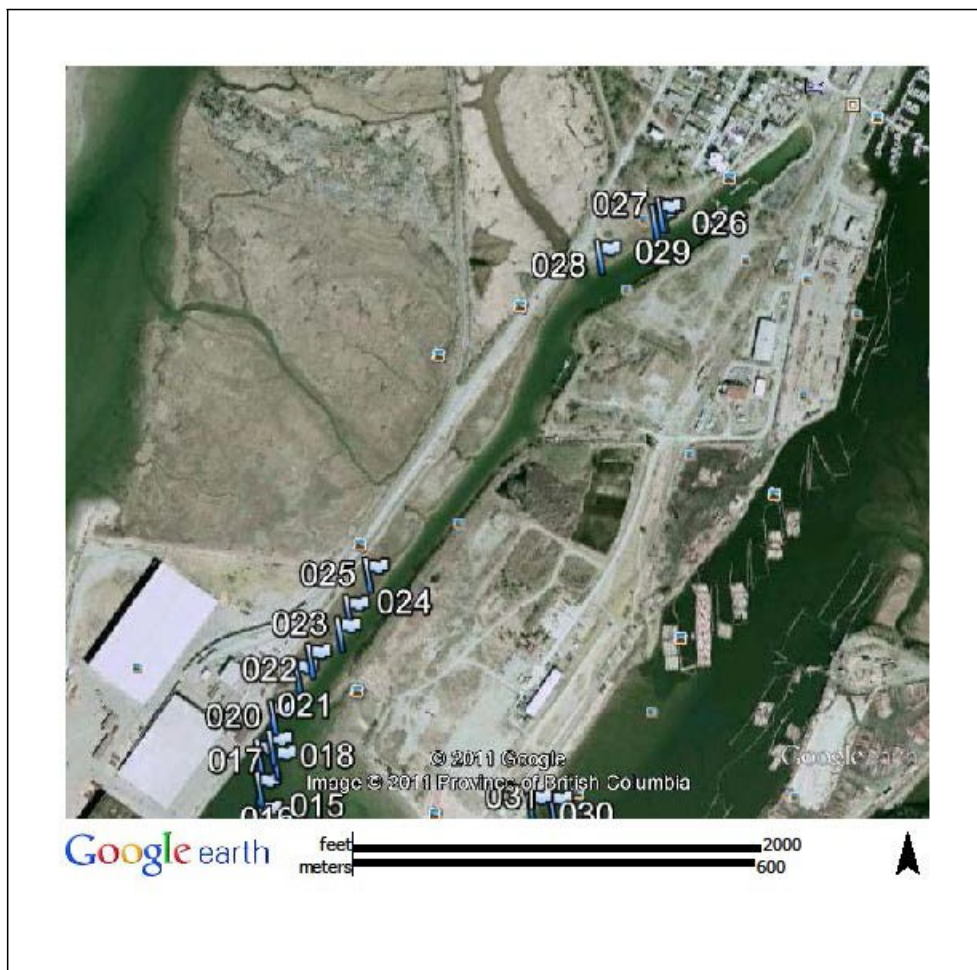
c) Cattermole Slough. View also includes shallow waypoints 23 through 25 and Site C waypoints 15 through 22.

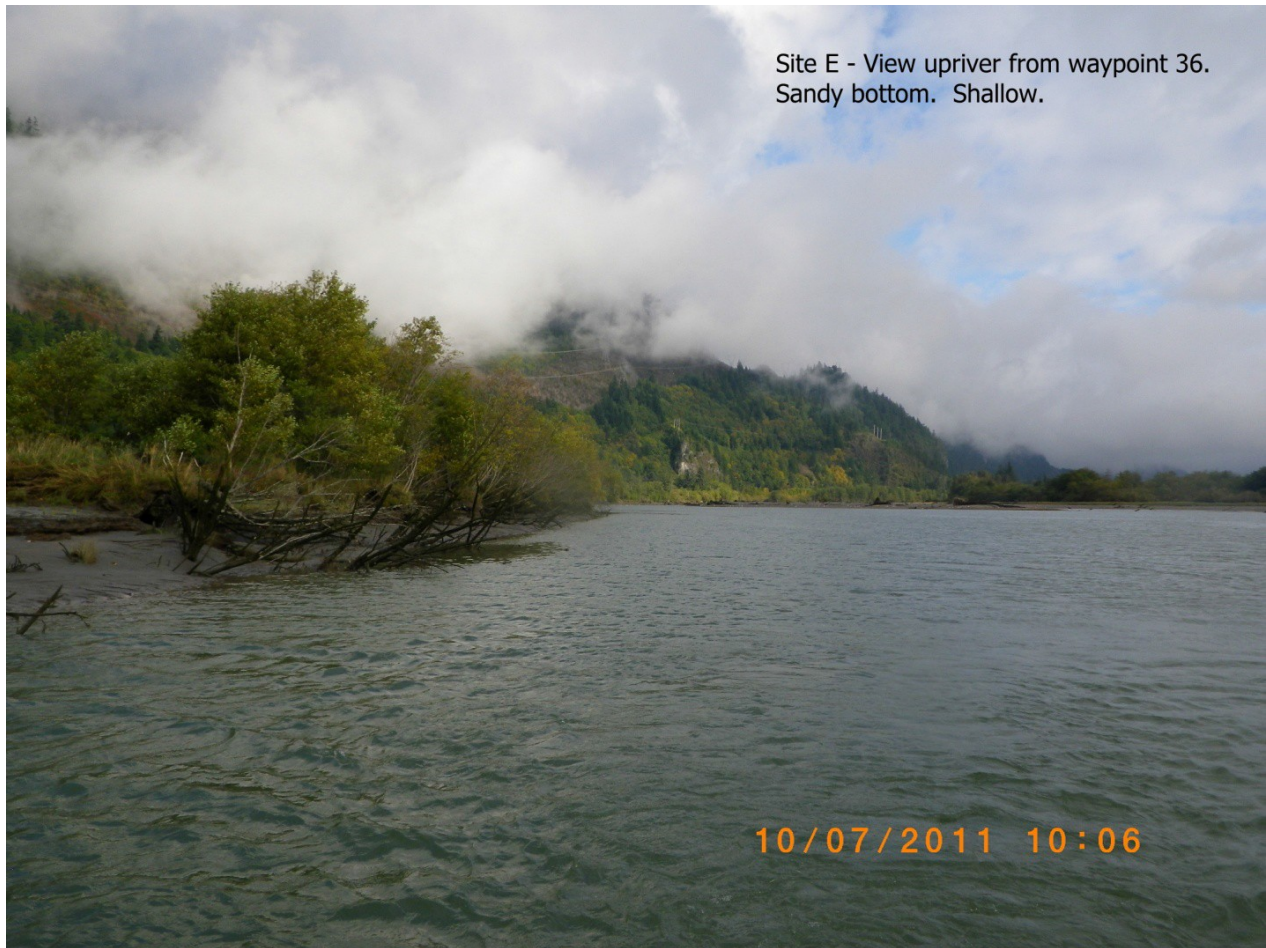
## October 7, 2011 – Site E

The substrate appealed, but we were not able to find sufficient depth in the western side of the Squamish River Estuary up stream of the river mouth for suitable transplant area.

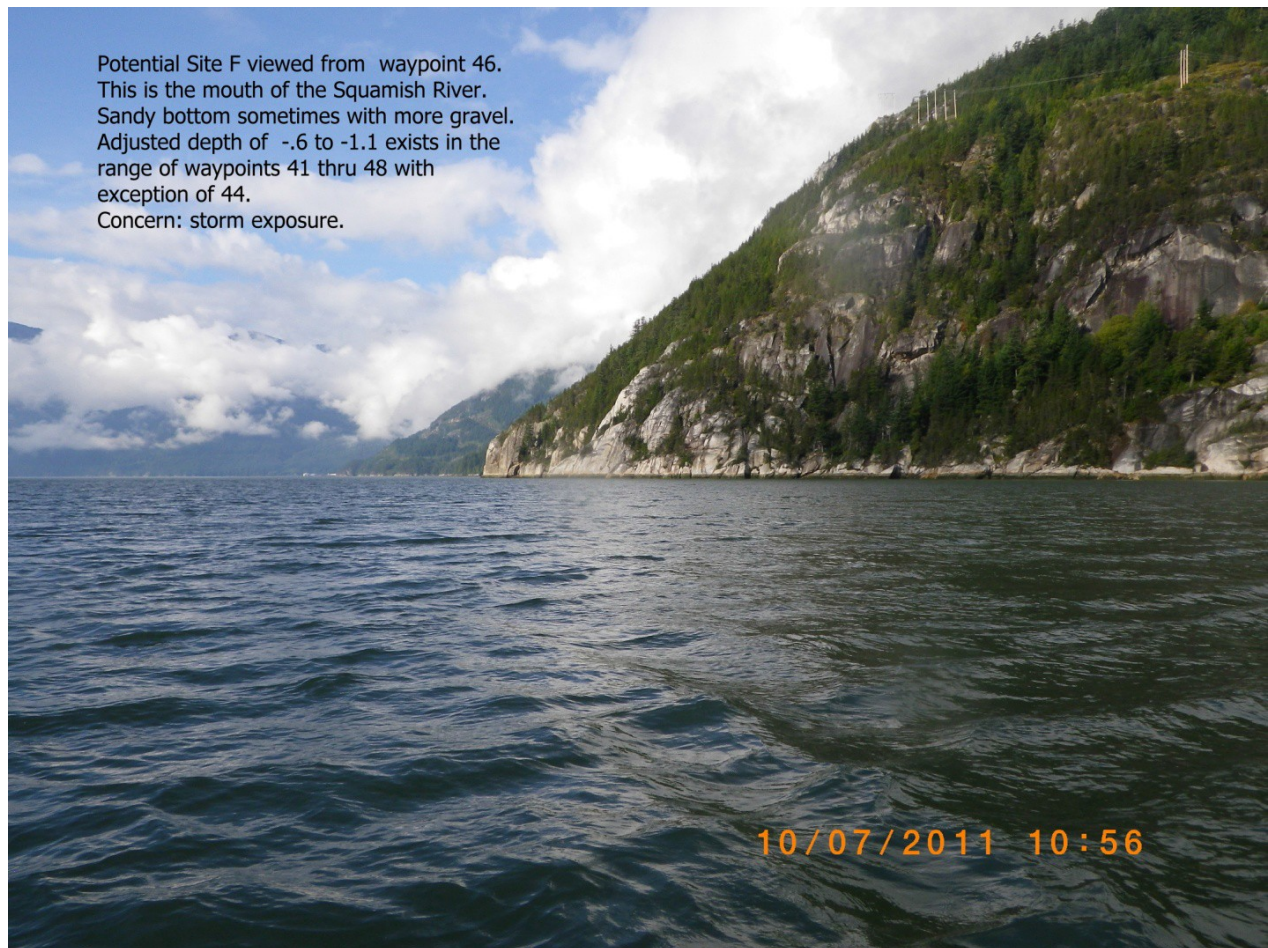
## October 7, 2011- Site F

This site extended across the mouth of the Squamish River with ideal substrate and a large area at an adjusted depth from -0.6 to -1.2 m. There are concerns regarding exposure to the elements. They are

- Exposure to river outflow including large volumes of rain and snow melt from the entire watershed.
- Storm waves resulting from a 7 km fetch.
- A combination of both items above at low water would be the worst anticipated scenario.

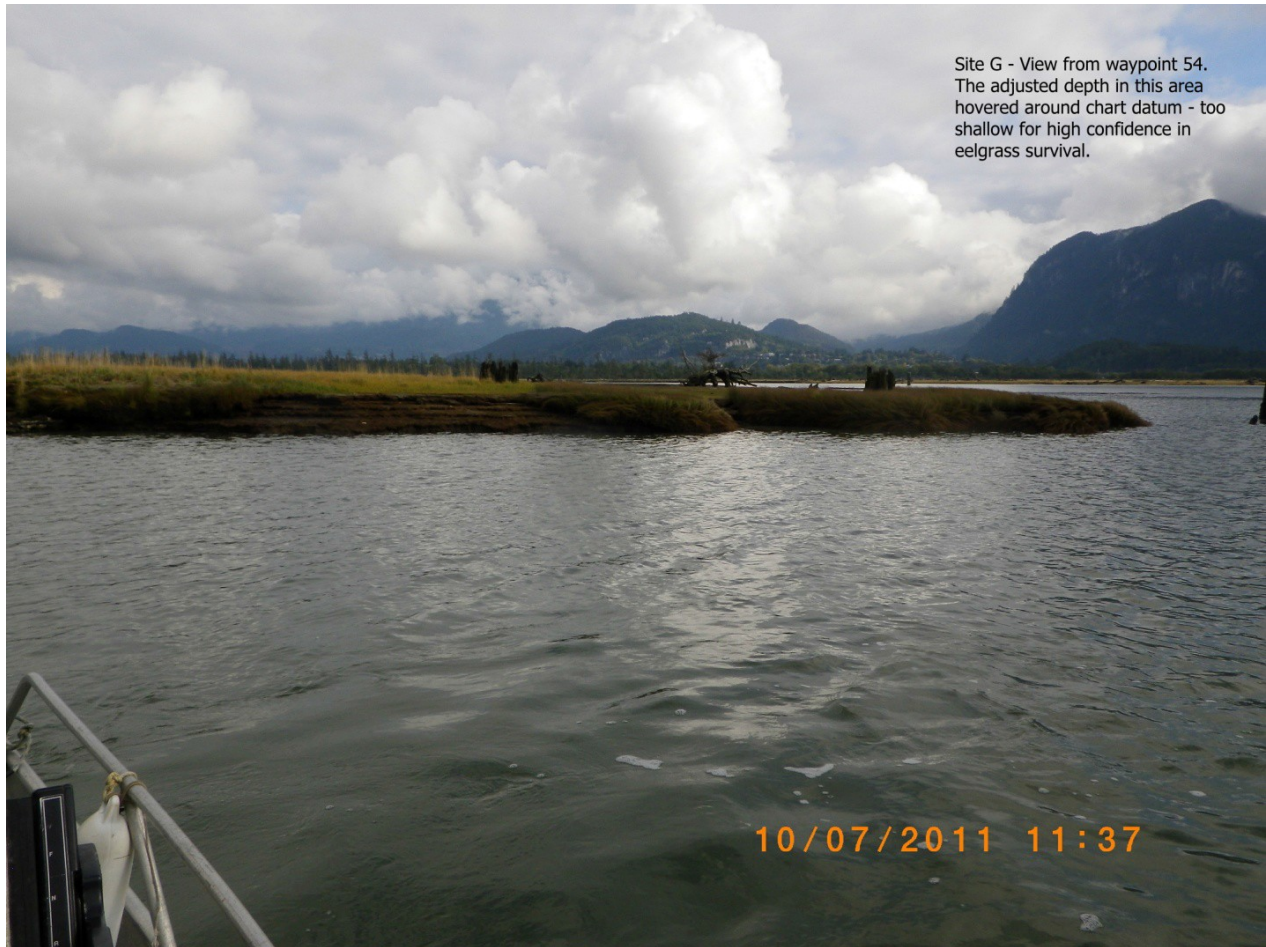
## October 7, 2011 – Site G

Site G - View from waypoint 54.  
The adjusted depth in this area  
hovered around chart datum - too  
shallow for high confidence in  
eelgrass survival.

This site included waypoints 53 through 58. Bottom varied from mud to a mix of mud and sand. However, the adjusted depth hovered close to chart datum. See Google Earth map following Site H for location of waypoints.

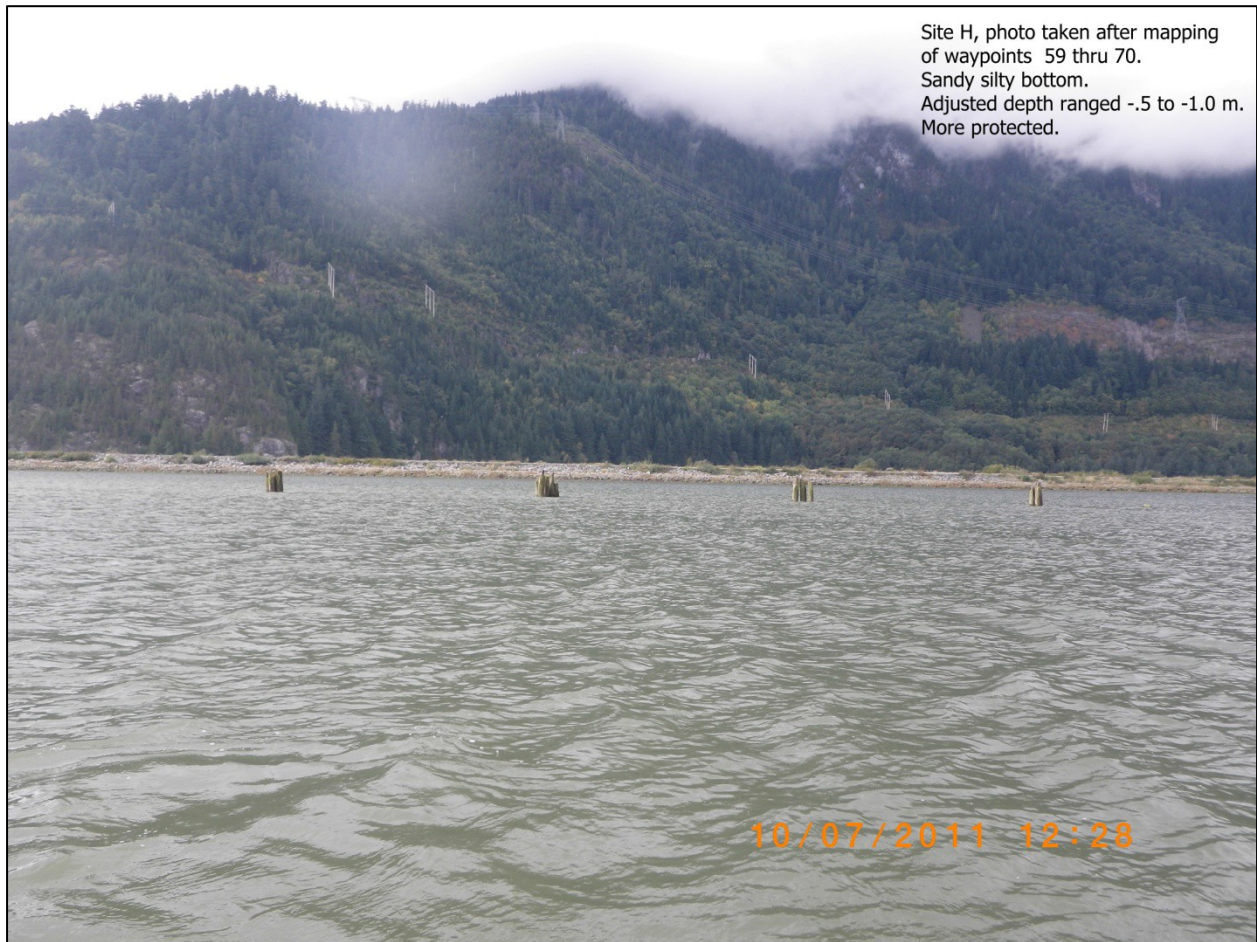
## October 7, 2011 – Site H

Site H mapping revealed a pocket of appropriate depth when adjusted for tide. The bottom was sand and mud that was less mucky than Site H. Salinity was 18.7 ppt which was uncharacteristically high of the samples taken. Most were nearly fresh water.

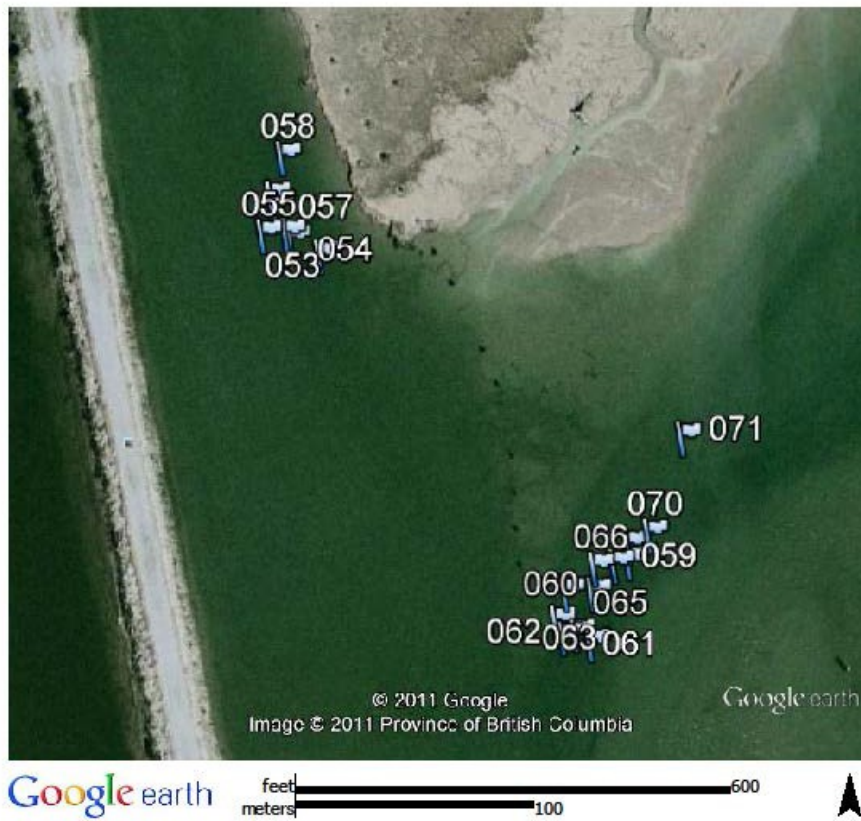
d) Waypoints for Sites G are 53 through 58. Site H waypoints run from 59 through 70. Water chemistry checked at 71.

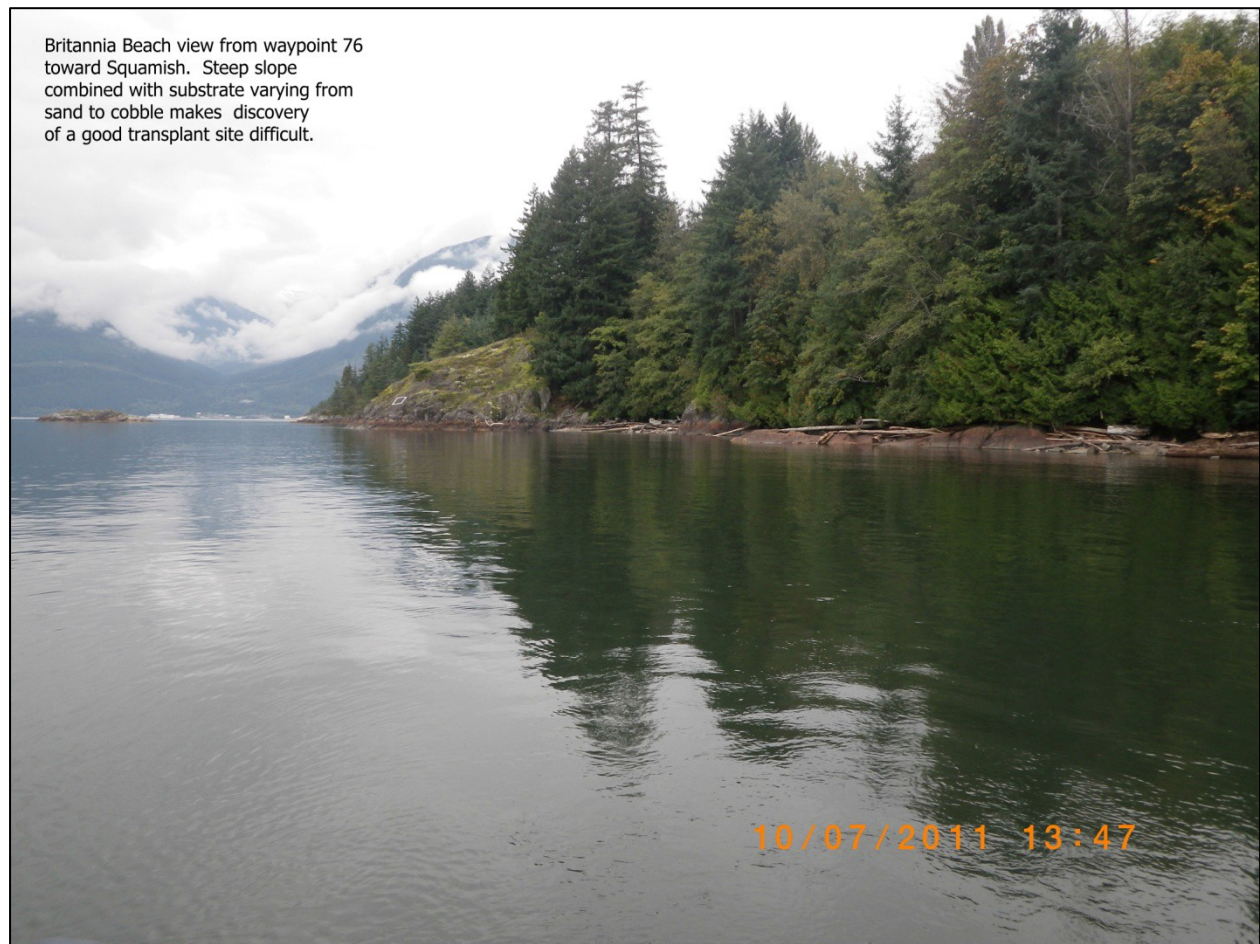
## October 7, 2011 – Britannia Beach

There was a possible viewing of eelgrass near Waypoint 84, but we were not able to confirm it. Two general areas for consideration included the mouth of Britannia Creek (waypoints 72-85) and Minaty Bay near another creek mouth (waypoints 86 through 89). Clean up of the toxins from the mine make the possibility of restoration in suitable substrate worth consideration. In the limited time available, we did not find a large area of proper depth and substrate.

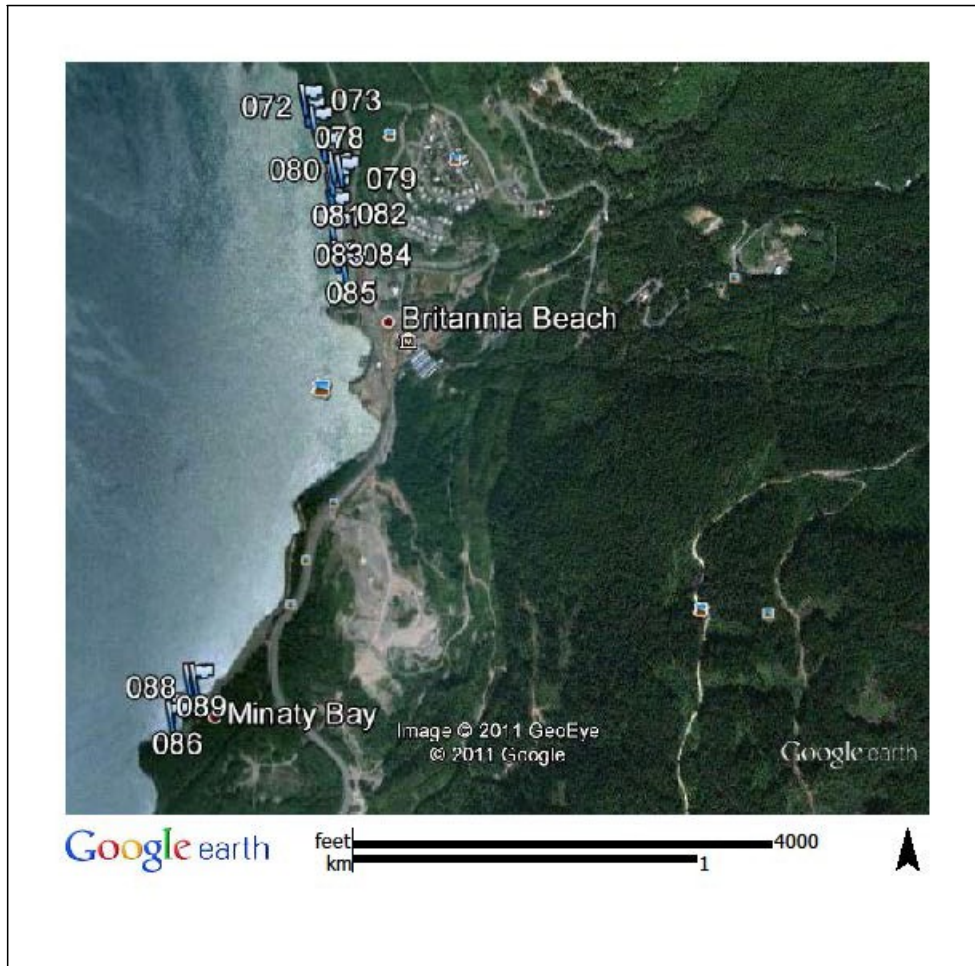
e) Waypoints for Britannia Beach and Minaty Bay.
